**LIGHTNING PERFORMANCE
IMPROVEMENT OF THE SWAZILAND
ELECTRICITY BOARD TRANSMISSION
SYSTEM (66kV & 132kV LINES)**

Submitted to the Department of Electrical Engineering, University of Cape Town, in partial fulfilment of the requirement for the degree of Master of Science in Engineering.

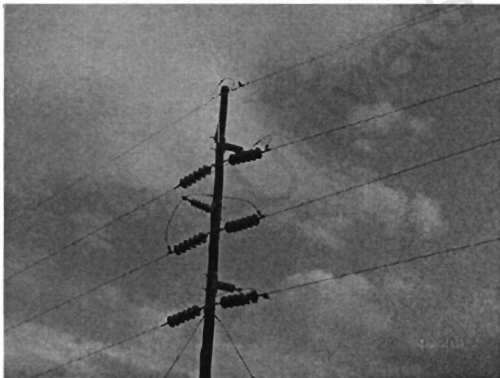
The system is predominantly constructed of wood pole structures. Structure type varies depending on the topography of the route of the line. The structures are mostly of “H” type construction and single pole type construction. The former is predominantly utilized in mountainous terrain and the latter used where the terrain is relatively flat. A shield wire is installed above the overhead-line conductors in all the lines. The shield wire is grounded along the route of the line. Transformation from 66/11kV is through delta-star transformers. The neutral is grounded via a restricted earth fault protection current transformer. The 66kV line and associated equipment is designed for (BIL) 325KV (minimum), and (fault Current) 20KA (Minimum). The system is mainly made up of ring feeders with circuit breakers installed in each end of the line. Because of the size of the country, the majority of line lengths do not exceed 50 kilometres per circuit. Figures 8 and 9 show the single pole structure and the “H” type pole structure construction

Figure 8: 66kV Single Pole Structure

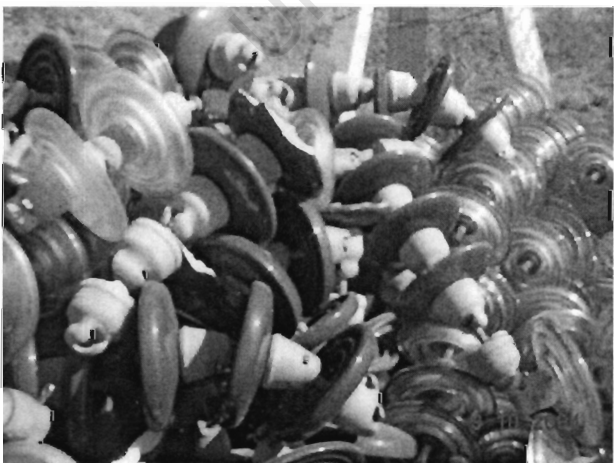
Visual condition assessment inspection along a number of 66kV lines uncovered a number of damaged insulators. The damages ranged from partially shattered disks to completely broken disks. The purpose of the inspection was to determine the extent of damage caused by the effect of flash over and to manage and carry out a remedial course of action to ensure that the lines perform as designed over a full life cycle of the line so that operational targets are achieved. Several transmission lines situated within the high ground flash density area were visually inspected. The lines were photographed and figure 23 shows the damage to insulators found along them.

Figure 23a: Porcelain cap partially shattered with burn marks visible on the top disk.

Figure 23b: Damage on the second disk

Figure 23c: Damage on the first and the last disk

Figure 23d: First two disks broken

Figure 23e: Broken porcelain sheds on the line post insulator

Figure 23f: Severely burnt porcelain sheds due to flash-over

Figure 23g: Severely burnt porcelain stay insulator

Figure 23h: Defective insulators removed from the system

Most of the damaged insulators were found on transmission lines evenly spread out in the high lightning ground flash density area in the western part of the country. Some however were found on transmission lines located on the eastern part of the country where lightning ground flash density is lower than in the western region. This is attributable to the high footing resistance found in this part of the country. This type of damage is related to flashover activity. The damaged insulators were found mainly on the lines located in the western part of the country evenly spread out. There were no indications that the damage could have been caused by leakage current corrosion. Figure 23f shows a severely damaged porcelain shed indicating the extent of the burn from flash over. This type of damage results in high maintenance and replacement cost.

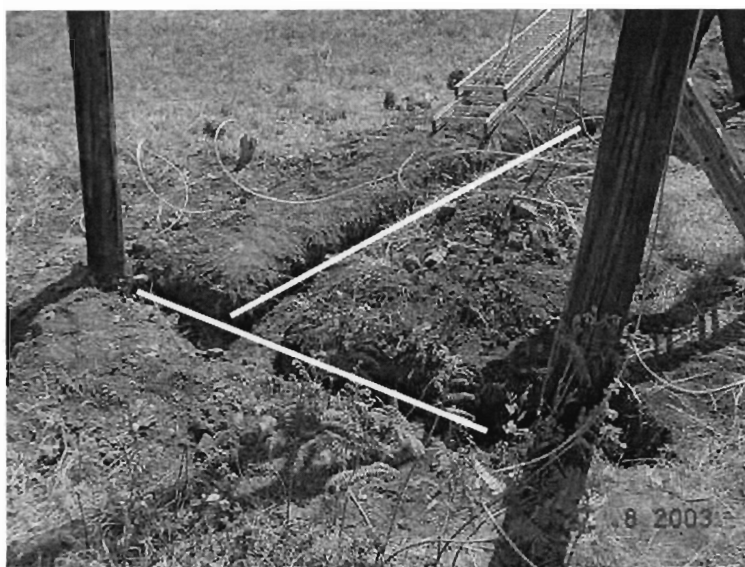
Most of the footing resistance values were found to be high. Radial counter poise earth improvement was applied to most of the structures. In addition, some conductive cement was used to enhance soil resistance in four of the structures. Figure 24 shows an open trench before back filling with conductive cement.

Figure 24: Connecting the ground wire to the wood-pole structure. Trench at the foot of Structure No. 4:

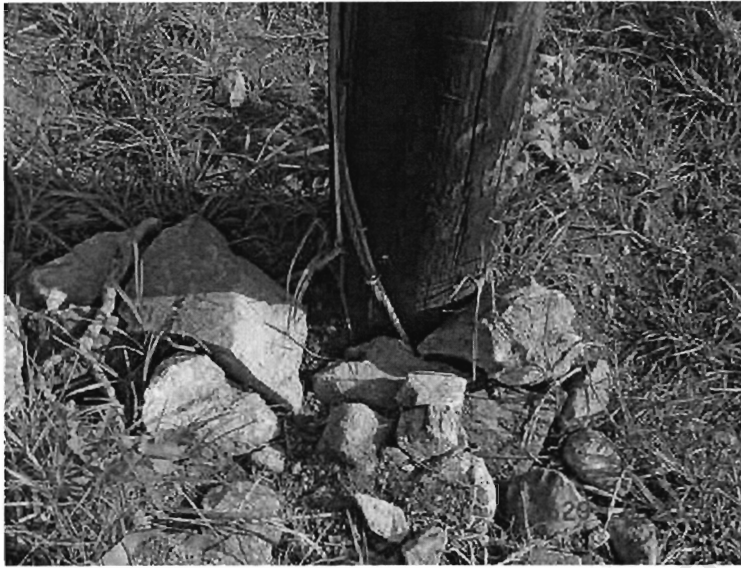
Figure 26: Earth composition at the base of StrutureNo.21

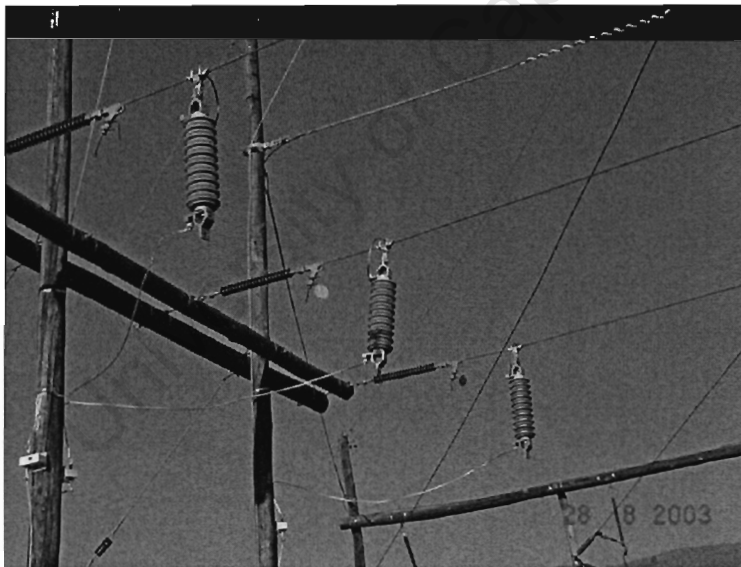
Figure 29: Completed Installation of 66kV Surge Arrester Units
Source: Project implementation photos - Mswane
